BGA inspection and rework with HR 600/2

Failure analysis and assembly repair

Case description

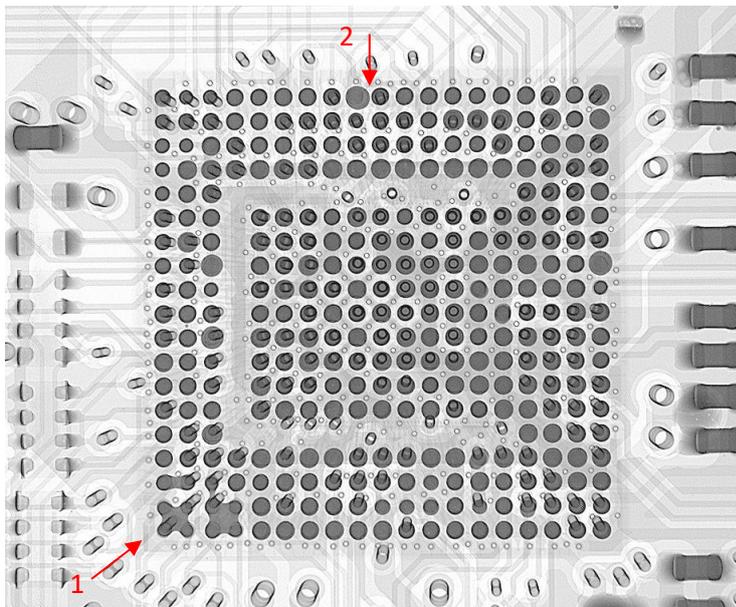
Before Ersascope inspection the assembly has been x-rayed, with the idea to offer the customer a comparison of x-ray and Ersascope inspection and the option to utilize both technologies in combination for failure analysis. On different boards the same type of errors appeared: multiple bridging and ball size variations.

Figure 1: BGA on assembly with multiple bridging (1) and extended ball size (2)

x-ray inspection offers a clear failure identification – reasons for the detected effects are not fully explainable.

Potentially related to the PCB layout (vias), pad shape and / or to the paste printing and reflow process (paste amount, thermal profile).

To fully encounter the possible reasons for the fault it was decided to replace the BGA component.

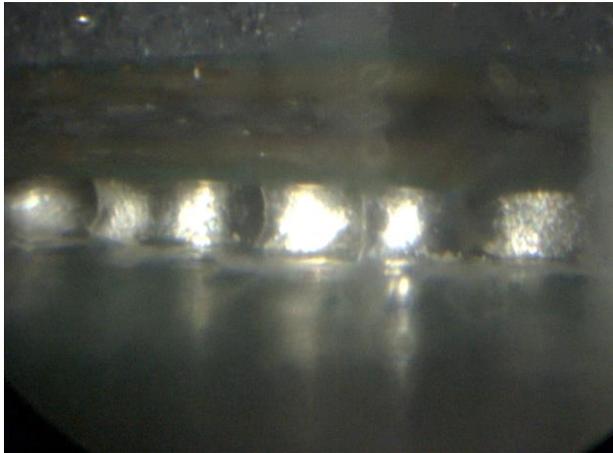
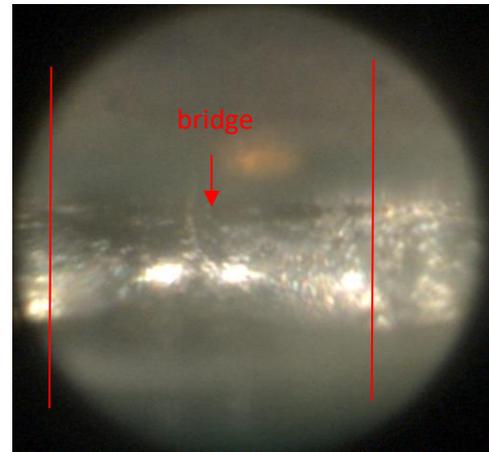
Figure 2 a: Multiple bridging (1) view with Ersascope & BGA head from left corner (see arrow in fig. 1) 2 b: flip chip head shows short (red = center of ball)

1. In the corner section (1) bridging is clearly visible balls are deformed concave instead of regular convex form.
2. At least one ball size (2) was extended and shortly before bridging to its next neighbour ball. The amount of solder in those 2 balls is different.
3. Inspecting regularly shaped balls even there the backlight is not visible from the front. At the same time x-ray inspection is showing no inside bridging.

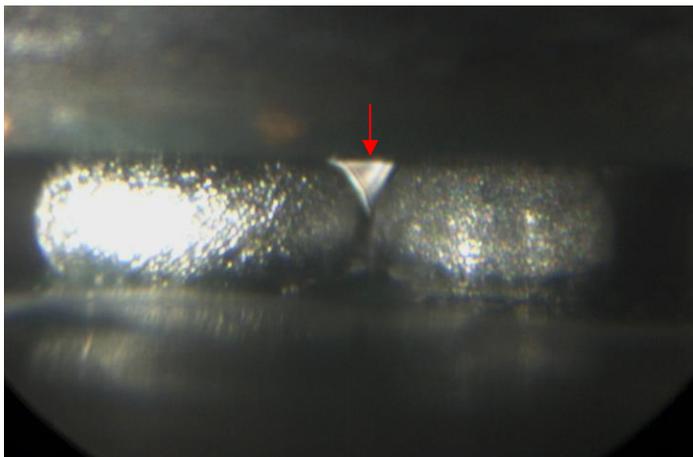
Figure 3: extended ball size (2) with Ersascope & BGA head straight view (see arrow in fig. 1)

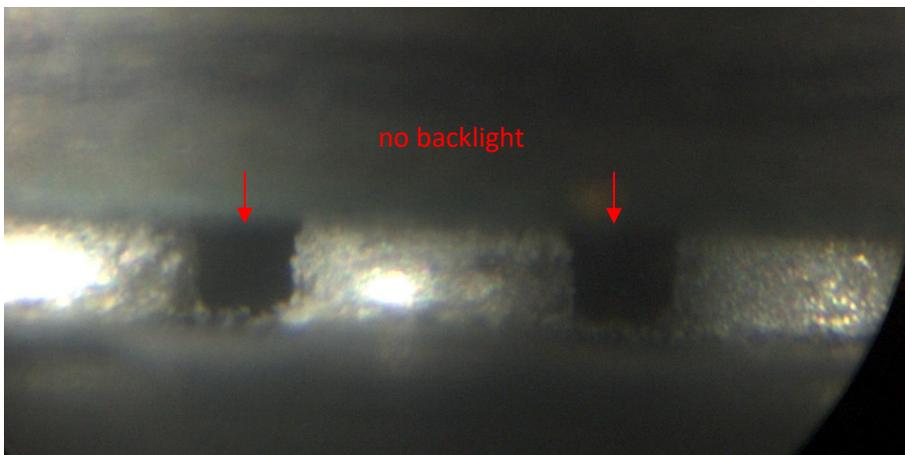
Figure 4: regular solder joints with no backlight visible between the balls

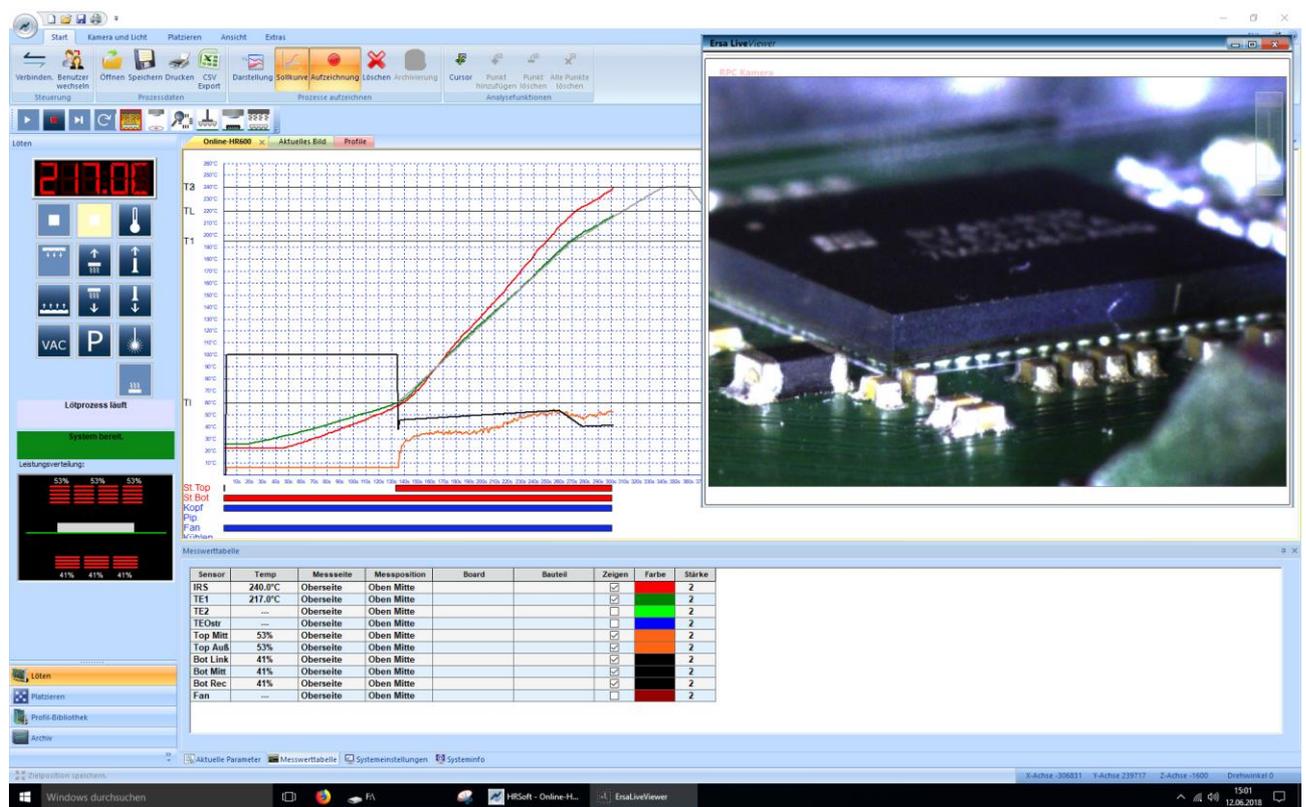
Figure 5: Desoldering BGA component with standard profile and reflow process camera observation

1. Removal of the BGA – even if the PCB had some internal mass layers, desoldering of the component was an easy job.

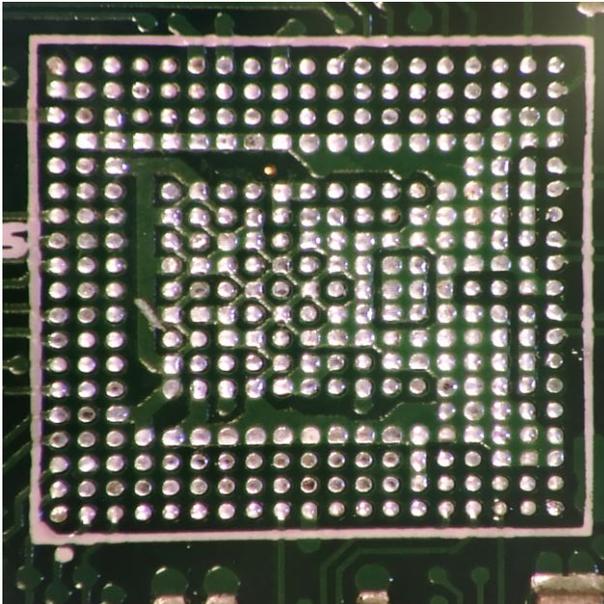
Figure 6: BGA pad pattern during rest solder removal indicates different pad geometries and via connections

Using a soldering iron and a ZD and AD tip (series 102) the residual solder was removed. Pads were washed off with flux remover.

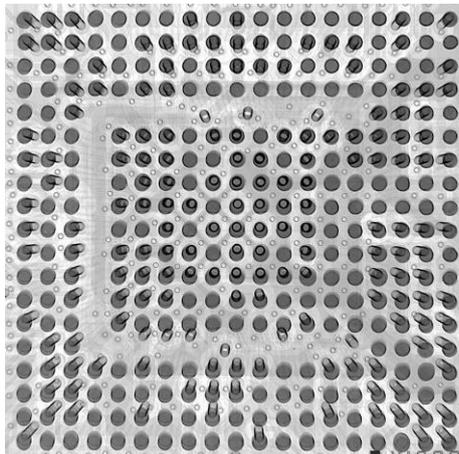
Figure 9: new BGA installed, no anomalies

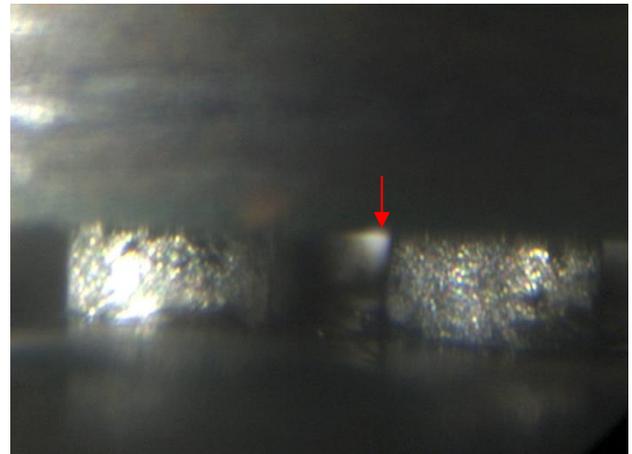
Figure 10: solder balls with backlight visible
