BGA inspection and rework with HR 600/2

Failure analysis and assembly repair

Case description

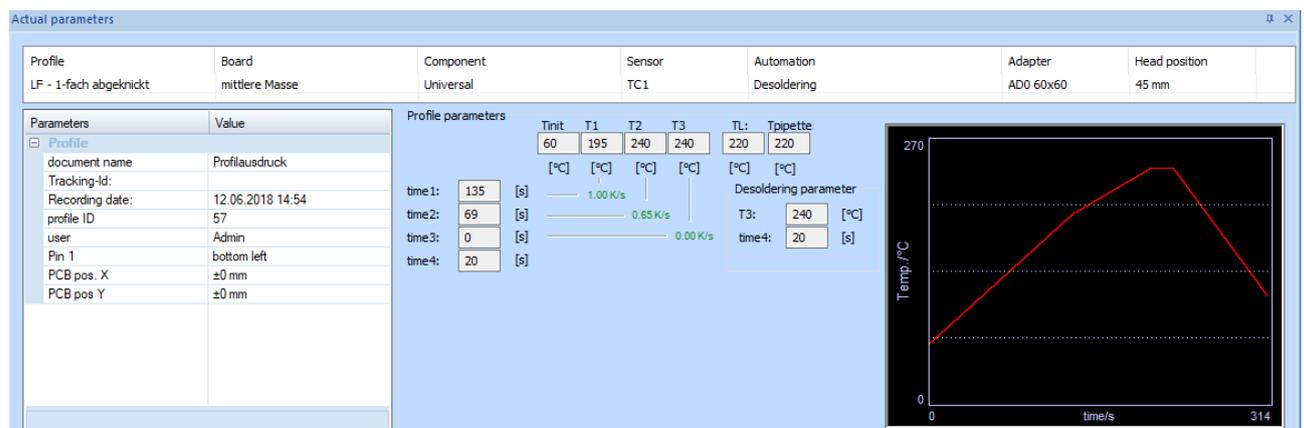
Figure 7: profile settings for BGA installation

For installation the same reflow profile has been selected like in the desoldering process. The component was dipped in a 150 μm flux stencil (with flux 4FMJF8300-005). No additional solder paste was added. The HR 600/2 used the automatic dip in function and located the component automatically on the right spot.

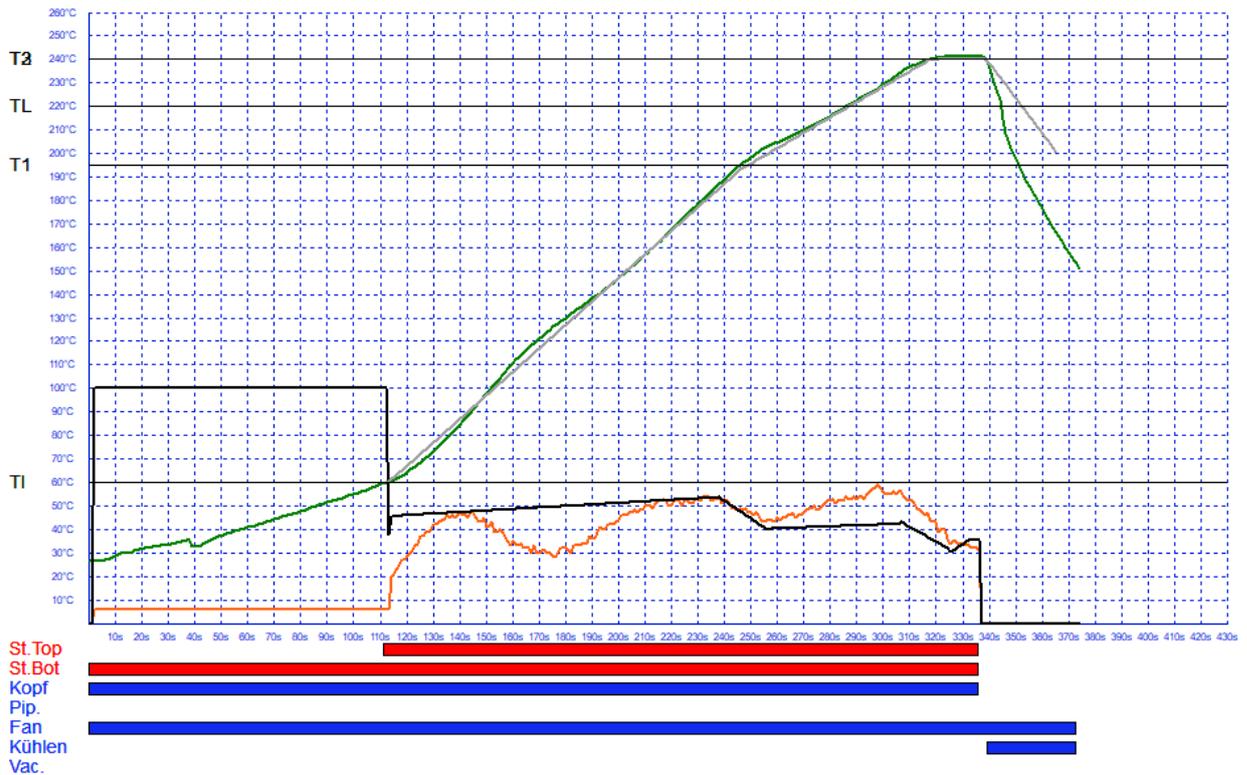
Figure 8: recorded soldering profile of BGA installation
